**RE: Exposed Rock Face Review**  
Proposed Residential Subdivision  
2-10 Ridge Road  
Block 80.03, Lots 10 & 21  
Township of West Orange  
Essex County, New Jersey  
Dynamic Earth Project No.: 4266-99-001EC

Dynamic Earth, LLC (Dynamic Earth) has completed a rock slope review for the above referenced site. The results of our review are detailed herein.

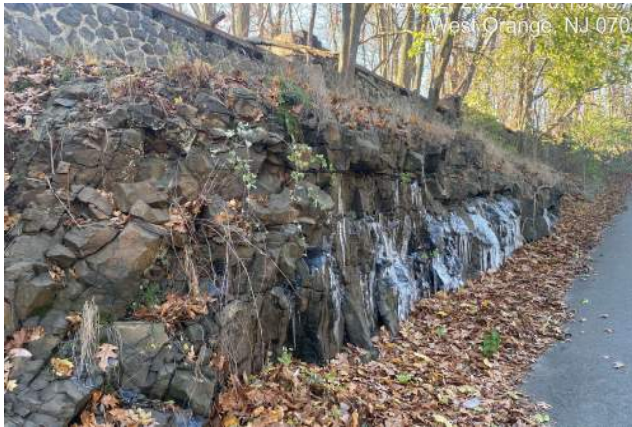
**Outcrop 1:** During our site visit, a rock outcrop approximately 262 feet in length located along on the northeastern portion along Mount Pleasant Avenue was observed. Based on visual observation, the exposed rock was subangular, moderately fractured and weathered grey siltstone. Icicles and wetness observed at the surface of the rock slope along the bedding planes.

Rock outcrops located along the northeast portion of the site (outcrop 1) indicated seepage and wetness. The presence of seepage and icicles could be a potential indicator of instability. Water filled discontinuities can potentially reduce the effective shear strength along the discontinuity plane by means of hydrostatic forces. In addition, the formation of ice can destabilize the block form of the rock face causing breakage of joint bonds. Outcrops 2 and outcrops 3 did not show signs of seepage or formation of ice at the time of our site visit. However, these areas should be monitored particular following precipitation and/or during the wet seasons of the year.

Photo 1 – Outcrop 1 (Seepage at the Surface)

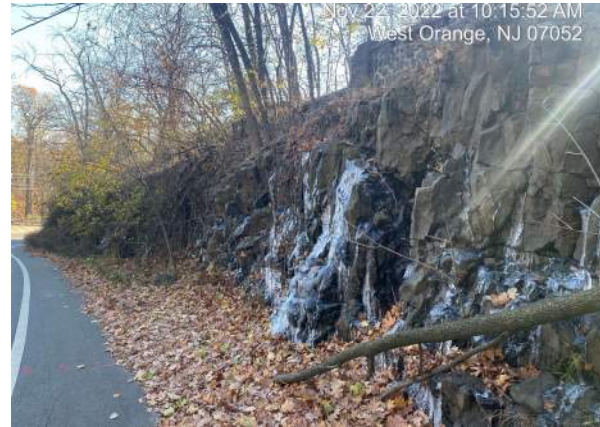
Photo 2 – Outcrop 1 (Seepage at the Surface)

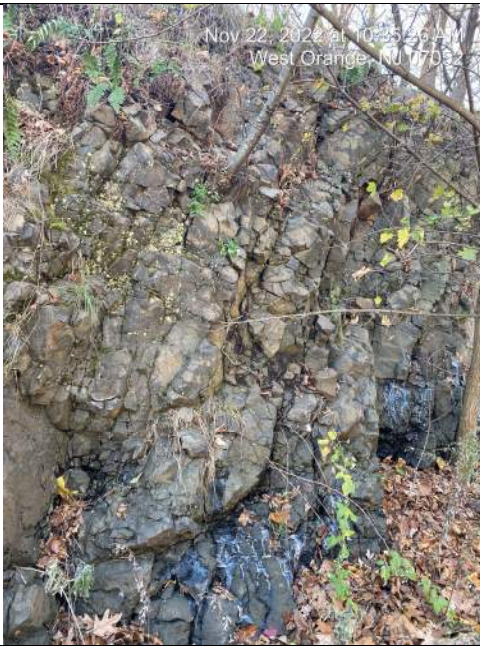
Photo 3 – Outcrop 1

Fracture planes observed with the persistent fracture plane ranged in thickness between approximately one foot and three feet, and included an angle of strike approximately 56 degrees in northeast and a bedding dip direction of 82 degrees to a strike direction of 24 degrees and dip direction of 85 degrees. Less persistent fracture planes were observed with thicknesses ranging between three to five feet included an angle of strike approximately 220 degrees northwest a bedding dip direction of 24 degrees to an angle of strike approximately 226 degrees in the northwest a bedding dip direction of 23 degrees. Both fracture planes consisted of fracture width varying approximately between 0.25 inch to one inch.

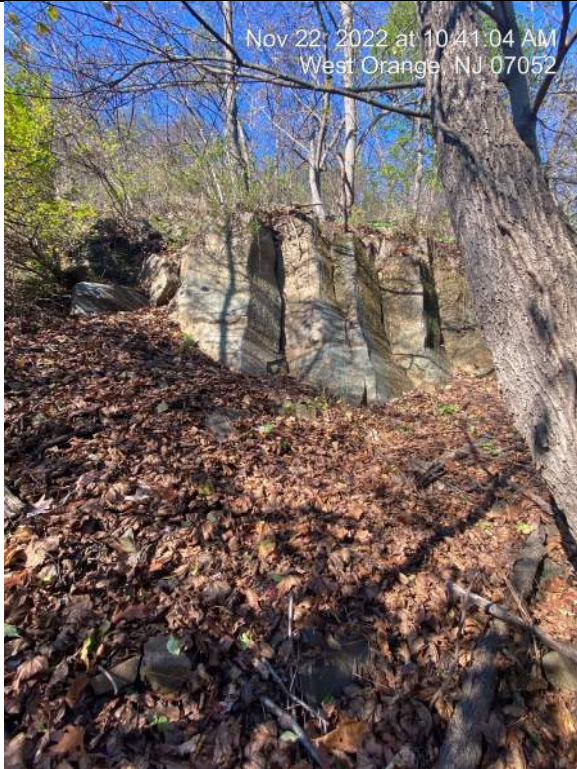
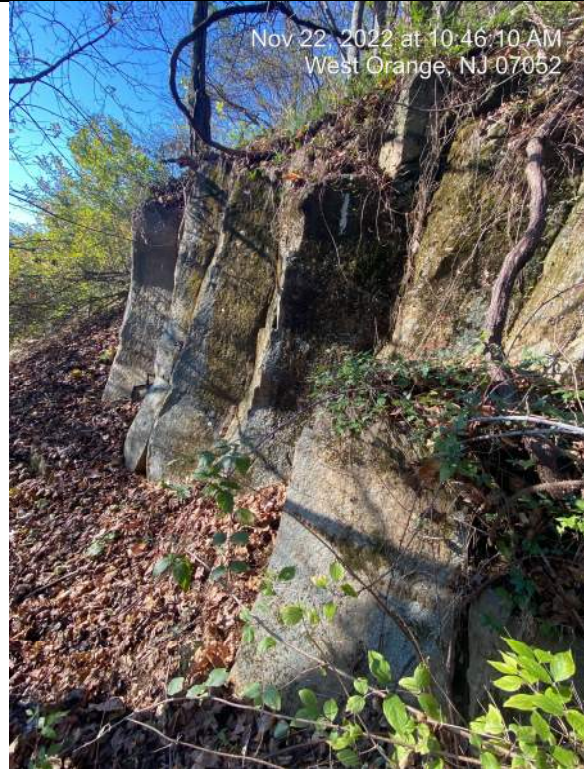
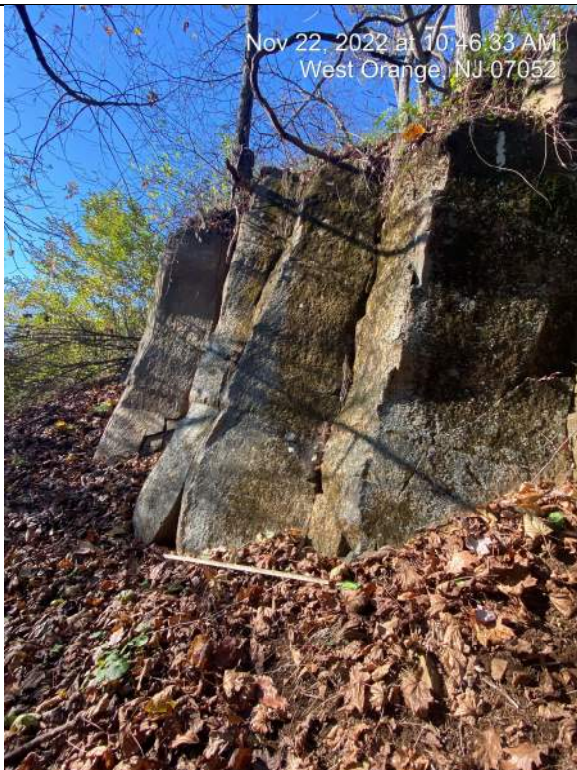
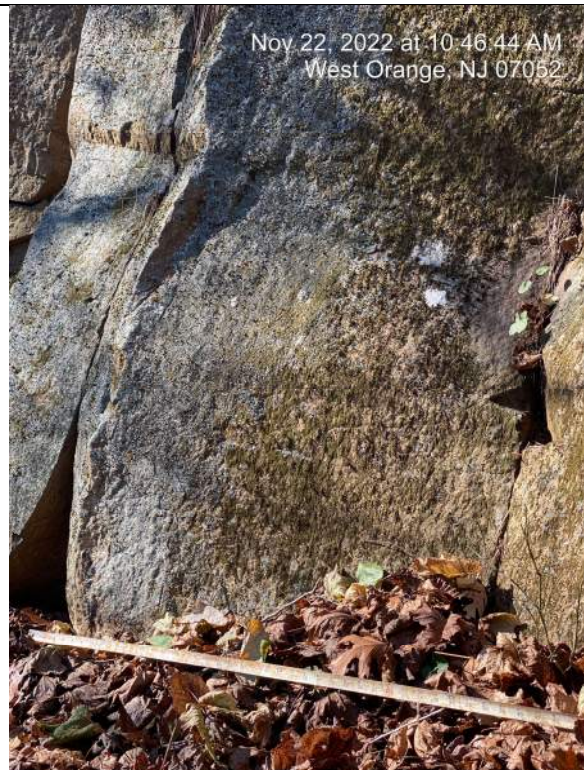
**Outcrop 2:** A second rock outcrop approximately 82 feet length was observed along the eastern portion of the site. Based on visual observation the rock surface consisted of dark grey basalt, slightly fractured and slightly weathered with massive columnar joints with joint heights larger than 10 feet. No surface wetness or seepage observed on the rock face.

Fracture planes observed the persistent plane indicated angle of strike approximately 150 degrees in southwest and a bedding dip direction of 83 degrees with joint spacing between three to five feet. Less persistent fracture planes indicated angle of strike approximately 216 degrees in the northwest and a bedding dip direction of 14 degrees and bedding thickness was spaced larger than approximately 10 feet. Both fracture planes consisted of fracture width varying approximately between 0.25 inch to one inch.

Photo 5 – Outcrop 2

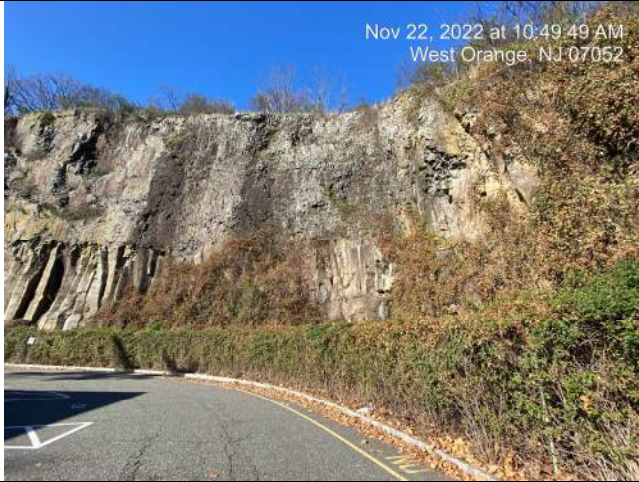
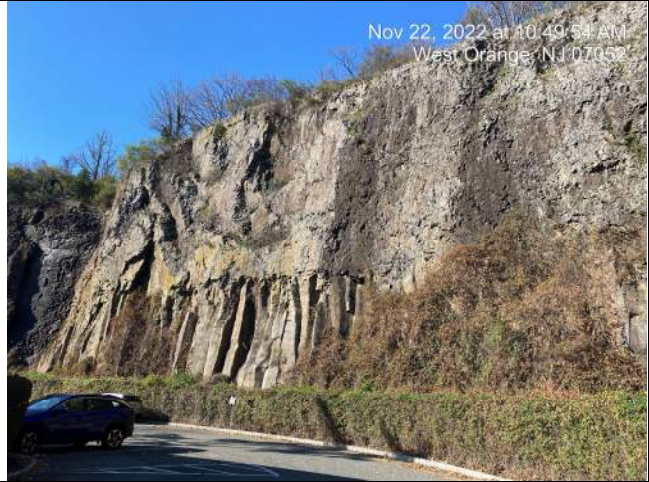
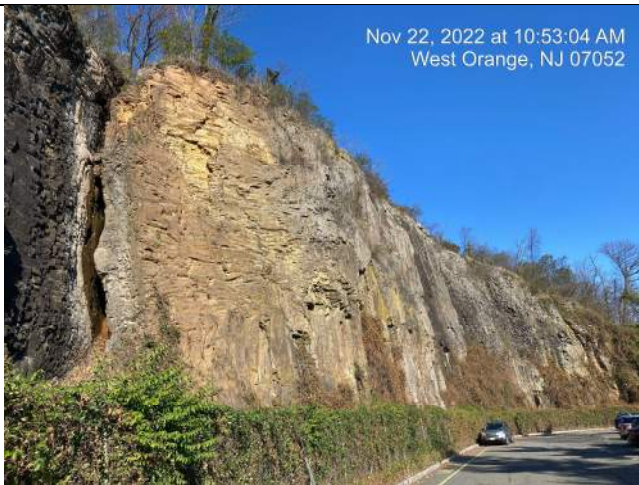
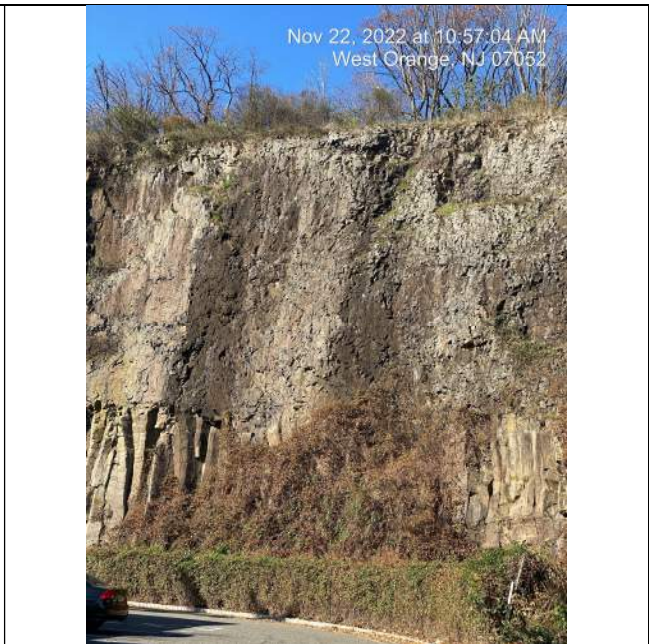
**Outcrop 3:** Approximately 582 feet length of the rock surface located along the property line between Crest Ridge Reality and the proposed site was observed and evaluated. Due to the limited access to the area, visual observations were made and rock strike and dip angles were not obtained. The rock surface consisted of dark grey basalt, slightly fractured and slightly weathered with columnar joints with joint heights larger than 10 feet underlying massive basalt beddings. No surface wetness or seepage observed on the rock face.

Photo 9 – Outcrop 3
