**RE: Further Evaluation of Langan Slope Stability Analysis, January 14, 2025, revised June 18, 2025**  
**PB-24-01 West Essex Highlands, Inc**  
**Block: 179 Lot: 32 Zone: IH-1**  
**Warner Road**  
**Project 2151.001**

#### **Recreation of Slope Stability Model Cross Sections C and D**

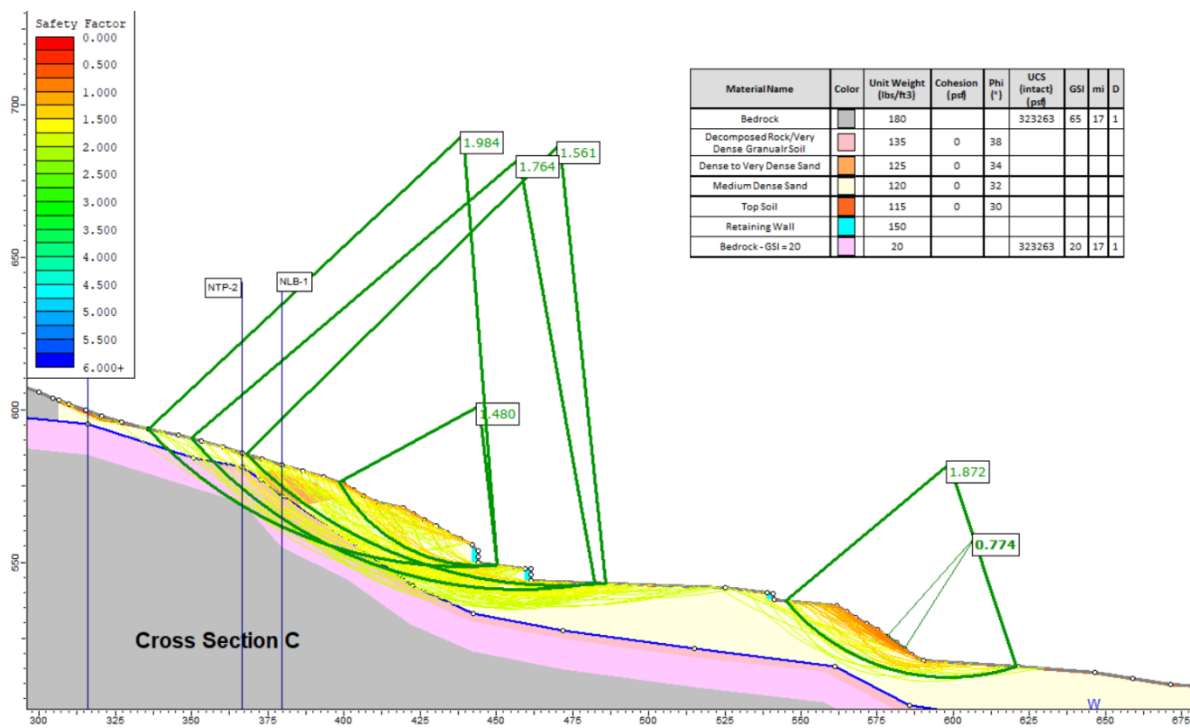
Figure 3: Cross Section C with Bedrock Layer of GSI=20

Numerous slip surfaces extending deeper into the subsurface were uncovered for both cross sections.

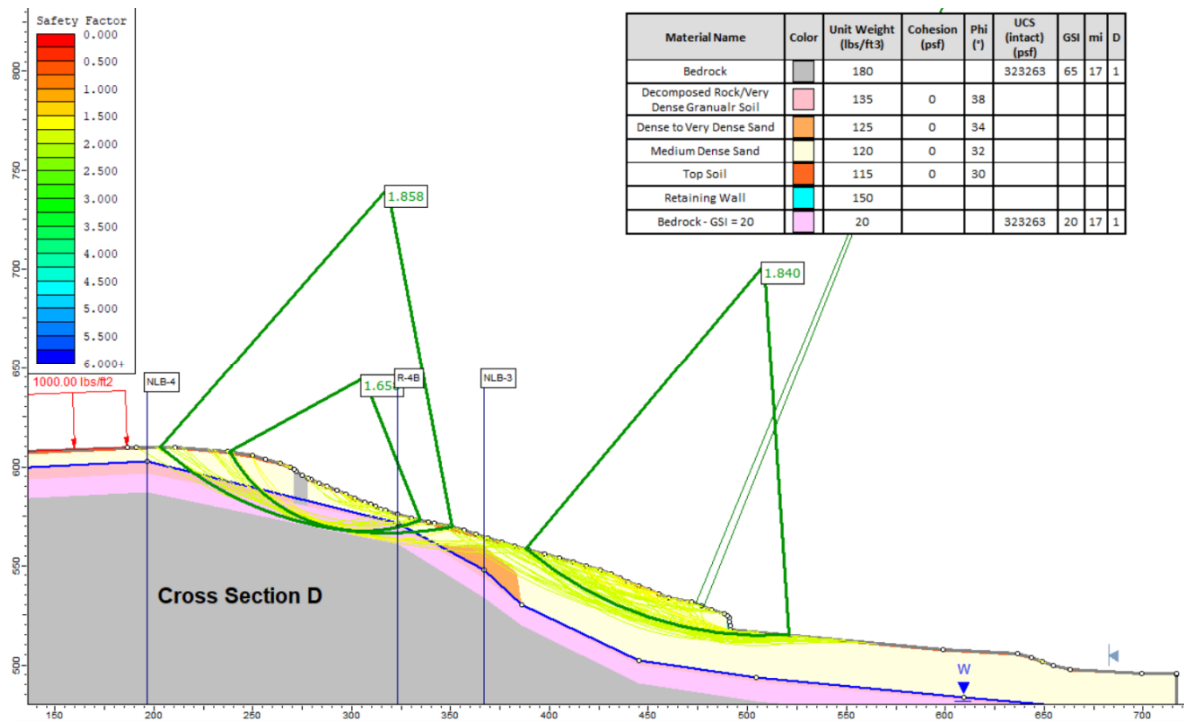
Figure 4: Cross Section D with Bedrock Layer of GSI=20
