## DAILY FIELD REPORT

| Project No.: <b>24006174A</b> | | Project/Location: <b>40 Eagle Ridge Way<br/>West Orange, Essex County, NJ</b> | | Date: <b>02/18/2025</b> |

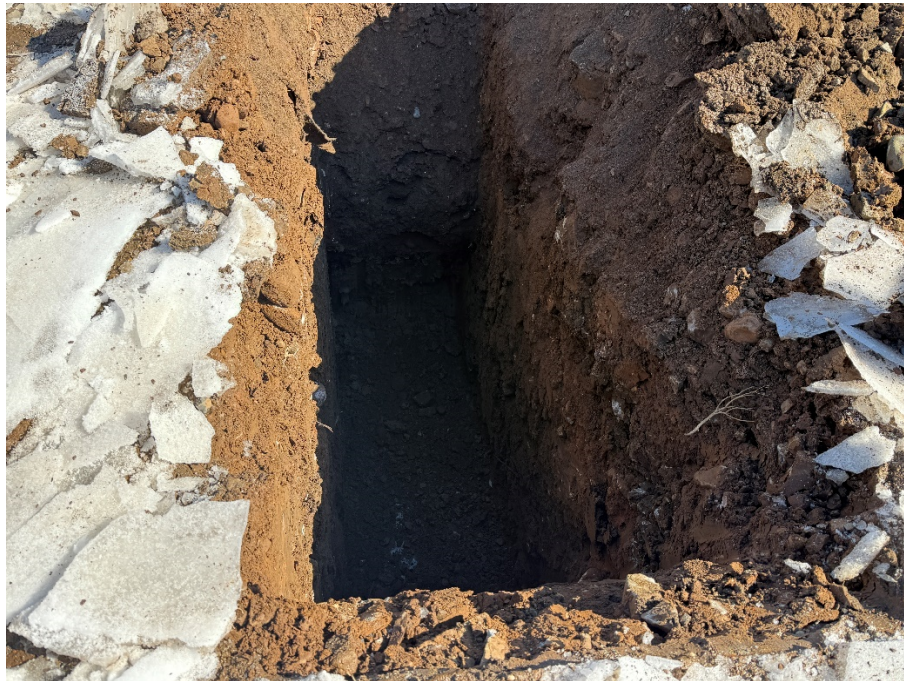
Photo 1: Test Pit TP-01

- Mobilized excavator to test pit location.
- Test pit terminated at 10 ft below existing grades due to subcontractor's concern with damaging existing stormwater system.
- Test pit backfilled to surface with excavated soil.

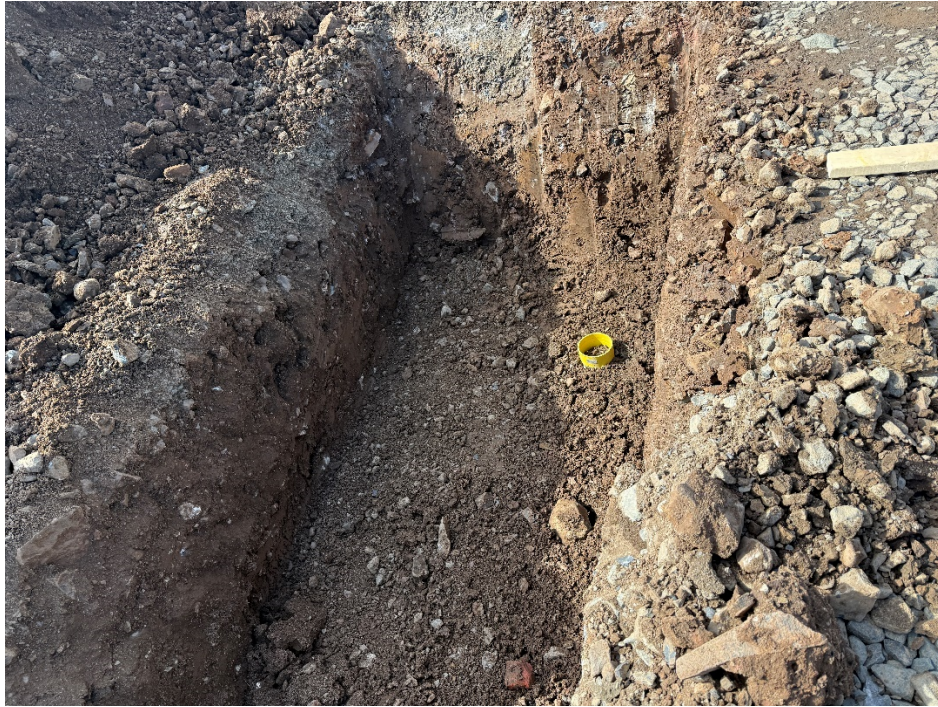
- Mobilized excavator to test pit location.
- Test pit terminated at 5.5 ft below existing grades due to refusal on bedrock.
- Performed infiltration test at 3.5 ft below existing grades (field infiltration rate +/- 6 in./hr).
- Test pit backfilled to surface with excavated soil.

Photo 2: Infiltration test at Test Pit TP-03

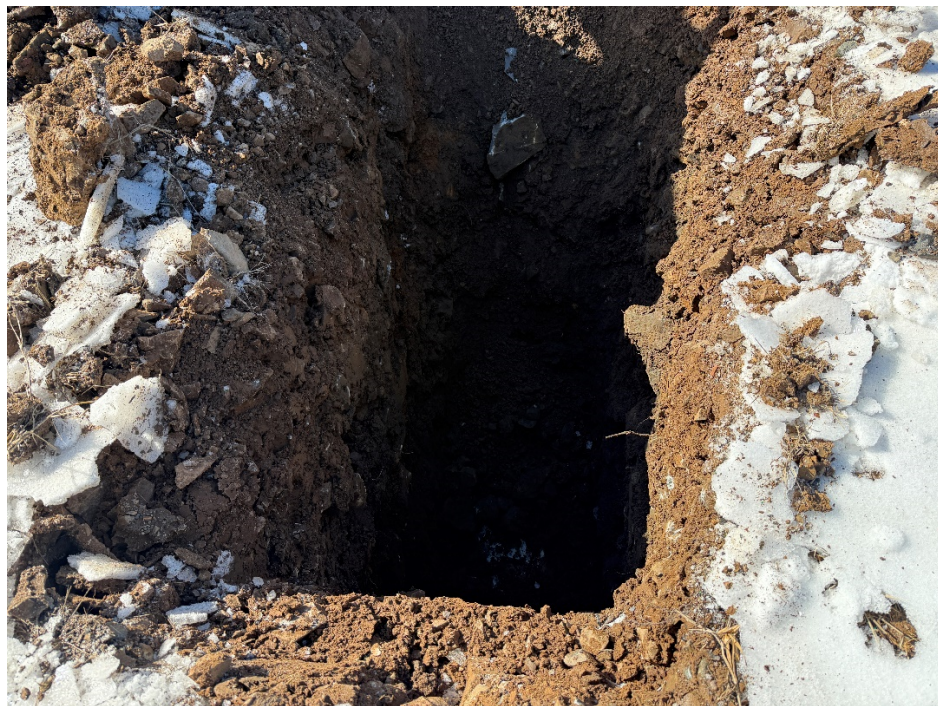
Photo 3: Test Pit TP-11

- Mobilized excavator to test pit location.
- Test pit terminated at 9 ft below existing grades due to refusal on bedrock.
- Test pit backfilled to surface with excavated soil.

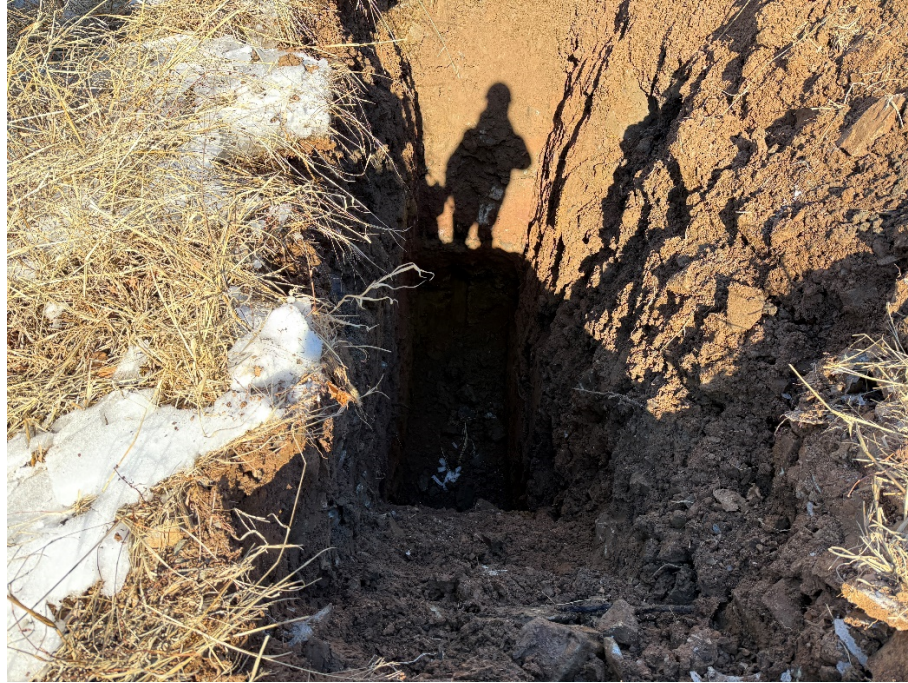
Photo 4: Test Pit TP-12

- Mobilized excavator to test pit location.
- Test pit terminated at 12.5 ft below existing grades due to refusal on bedrock.
- Test pit backfilled to surface with excavated soil.
