January 29, 2025

Ms. Rachael Dickinson  
Pre-Construction Project Manager  
Mavis Tire Supply, LLC  
200 Summit Lake Drive, Suite 350  
Valhalla, NY 10595

ECS Project Number: 44:2100-A

Reference: Addendum No. 1 - Results of Test Pit Excavation and Infiltration Testing  
**Mavis Store #2296**  
460 Prospect Avenue,  
West Orange, New Jersey

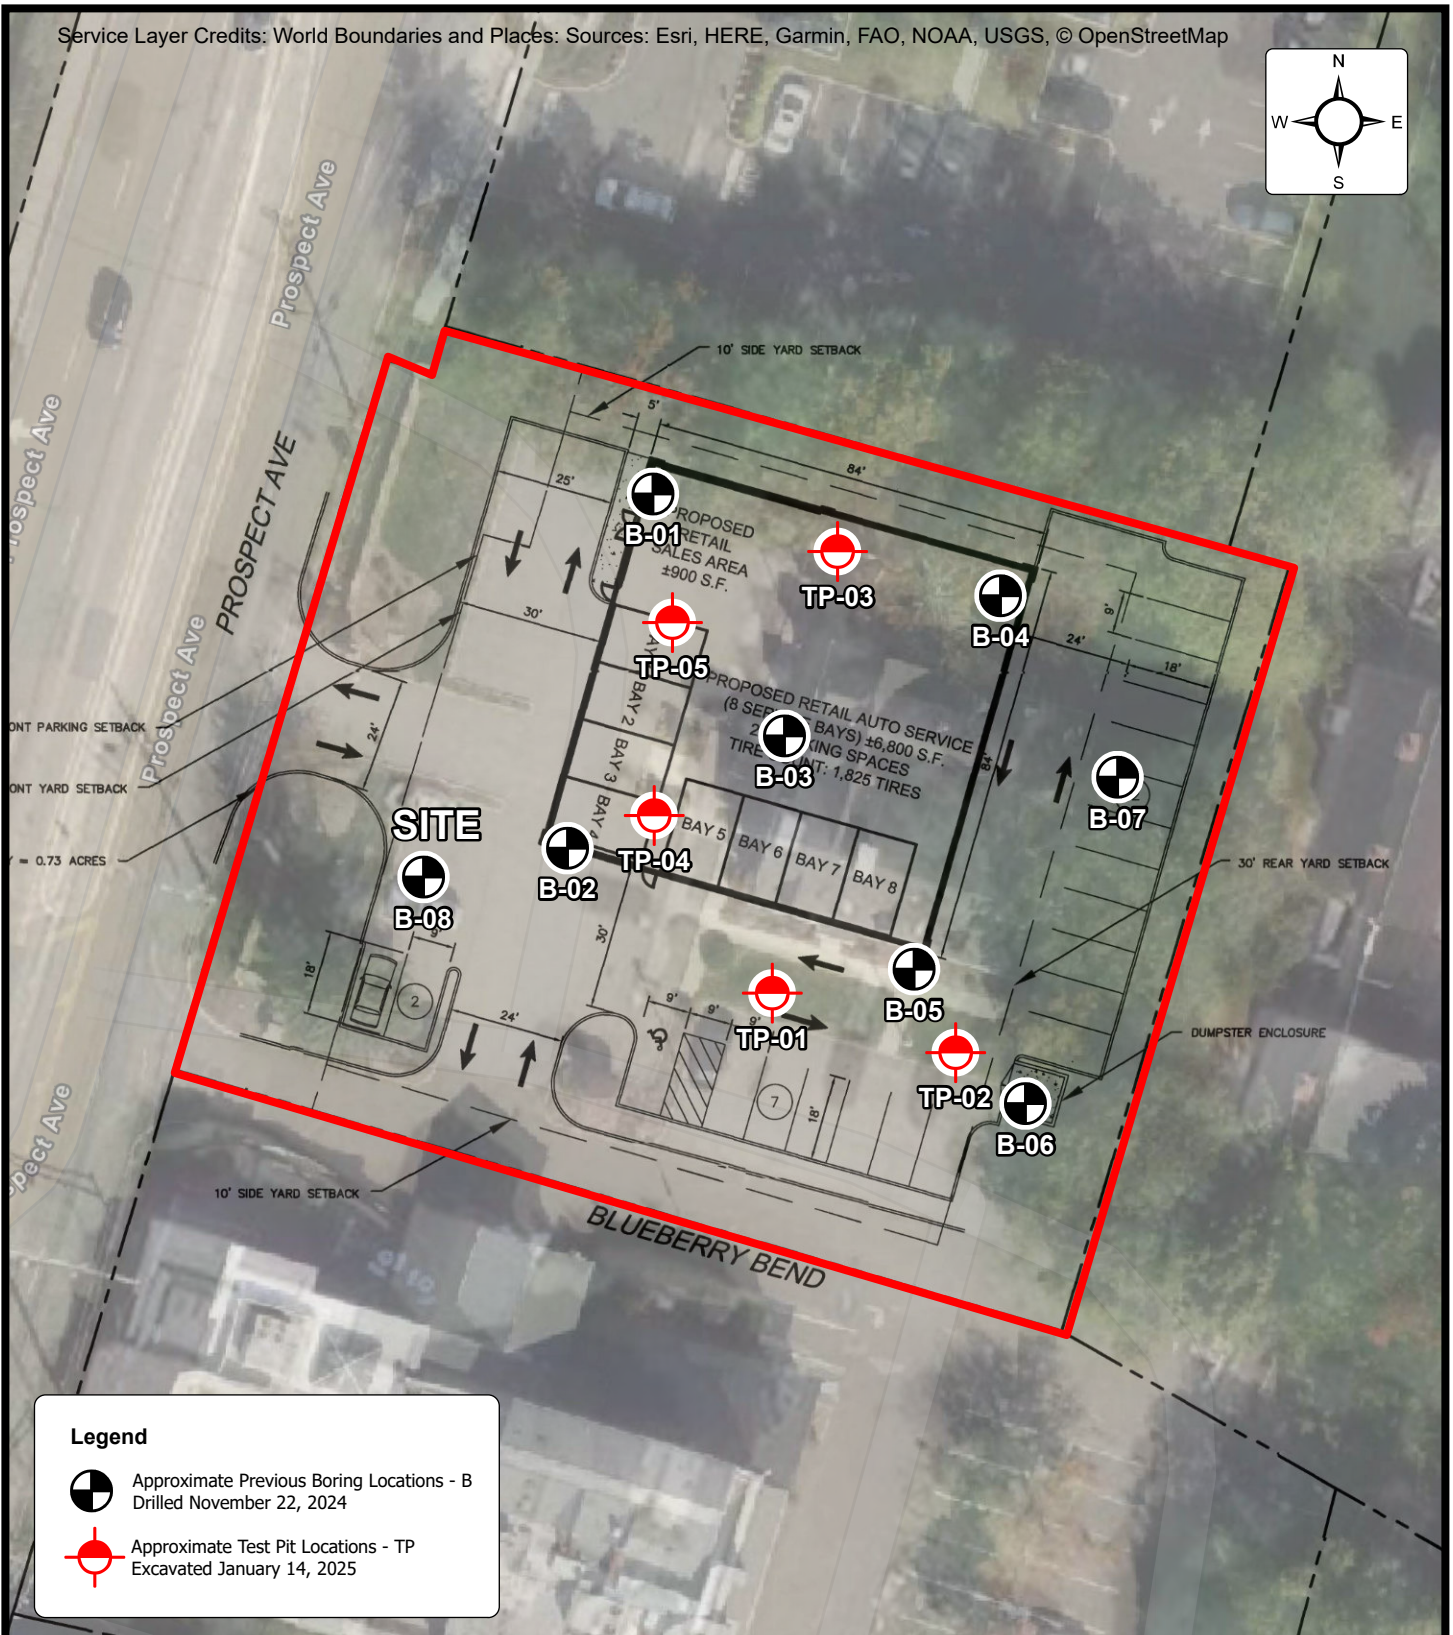
## EXPLORATION LOCATION DIAGRAM Mavis #2296 - Additional Infiltration

Our exploration procedures are explained in greater detail in the Attachment 2 in the insert titled Subsurface Exploration Procedure. A rubber tracked excavator was used by Sano Drilling, and the Exploration Location Diagram in Attachment 1 depicts the approximate as-completed locations of the test pit excavations. Soil profiling and field infiltration testing was performed in general accordance with Chapter 12 of the BMP Manual. The Single Ring Infiltration Test (Subsection A5 of the Chapter 12 Appendix) was used.

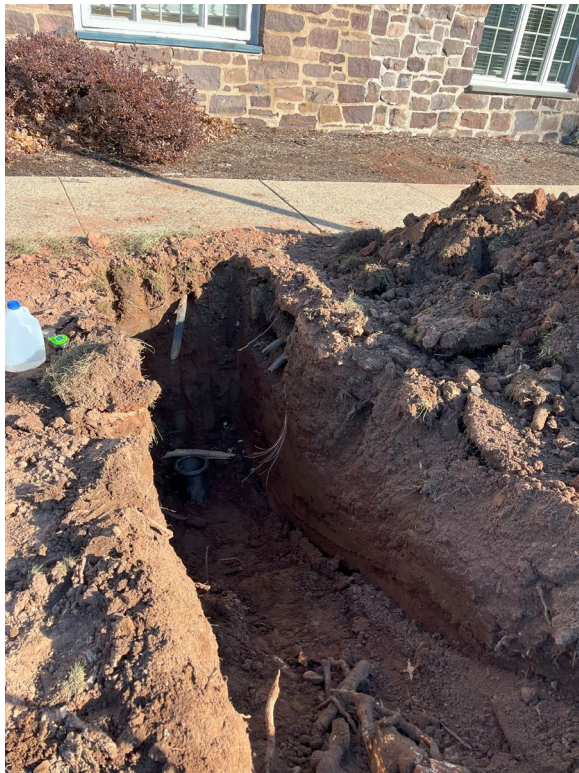
**Photograph 1 (Top left):**

TP-01: Sprinkler system, wires, roots between 0.5 and 1.5 feet below ground surface.

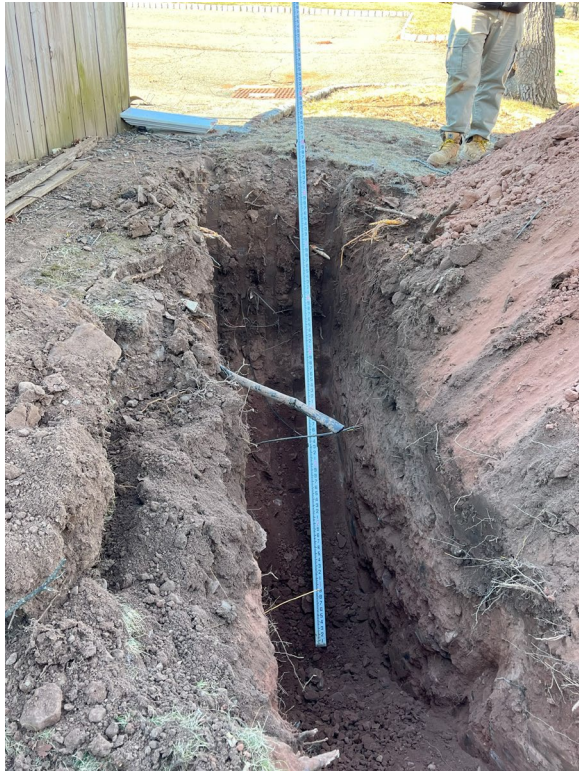
**Photograph 4 (Top left):**

TP-03: Sprinkler system and wires encountered between 0.5 and 3.0 feet below ground surface.

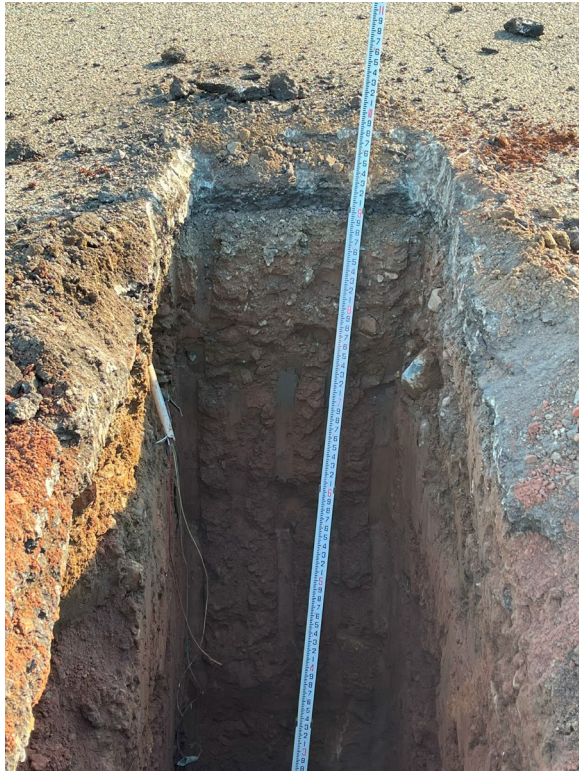
**Photograph 7 (Top left):**

TP-05: 10 inches of asphalt underlain by gravel. Wires, large gravel, cobble, and brick encountered between 1.0 and 3.0 feet below ground surface.
