**Bright View Engineering**  
*Moving you forward*

**Re: Safety Study**  
Abington Road & Deerfield Drive  
West Orange Township, Essex County, New Jersey  
**BVE Project No.: 241079**

Bright View Engineering was tasked by the Township of West Orange (*the Township here-in*) with performing an evaluation of the existing traffic controls at the intersection of Abington Road & Deerfield Drive. This analysis was performed to assess the safety conditions at the intersection and the installation of a stop control on Abington Road.

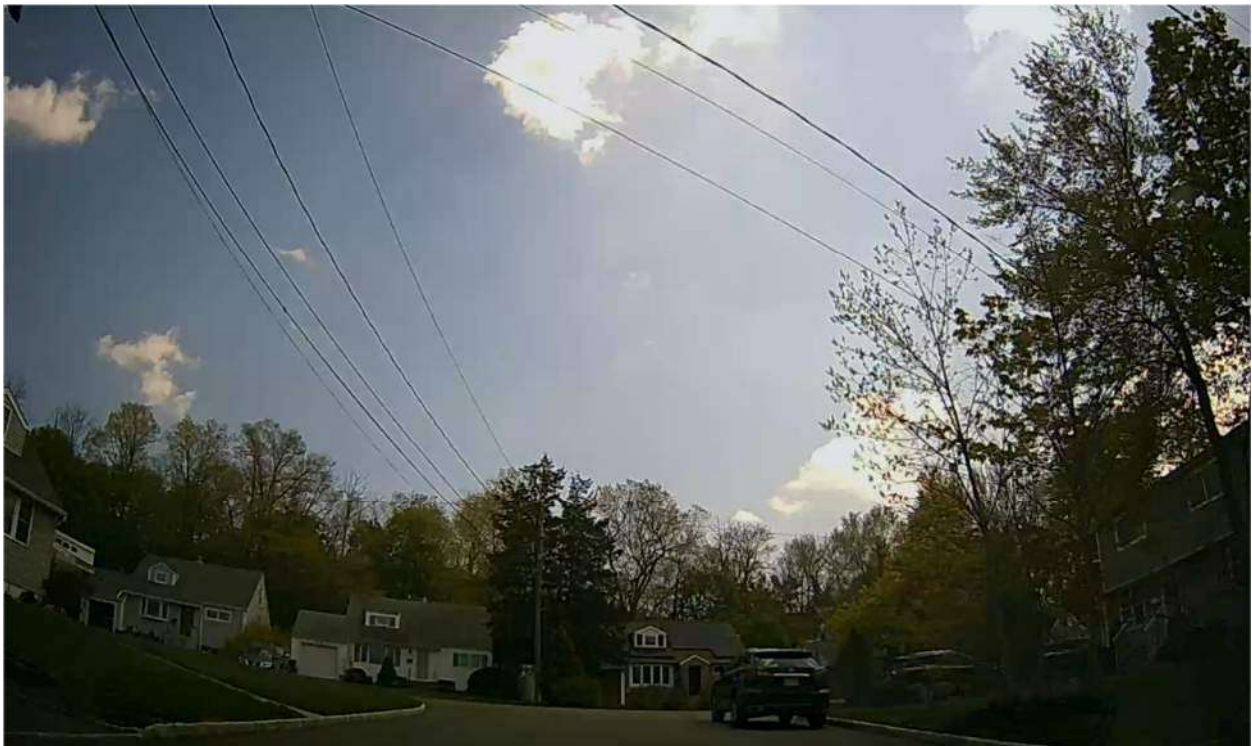
**FIGURE 2 – Abington Road & Deerfield Drive**

We observed that the sight lines at the intersection of Abington Road and Deerfield Drive are clear of obstructions.

It is our recommendation that a STOP sign be installed on the Abington Road approach at the study intersection. Treatments which can be considered include but are not limited to:

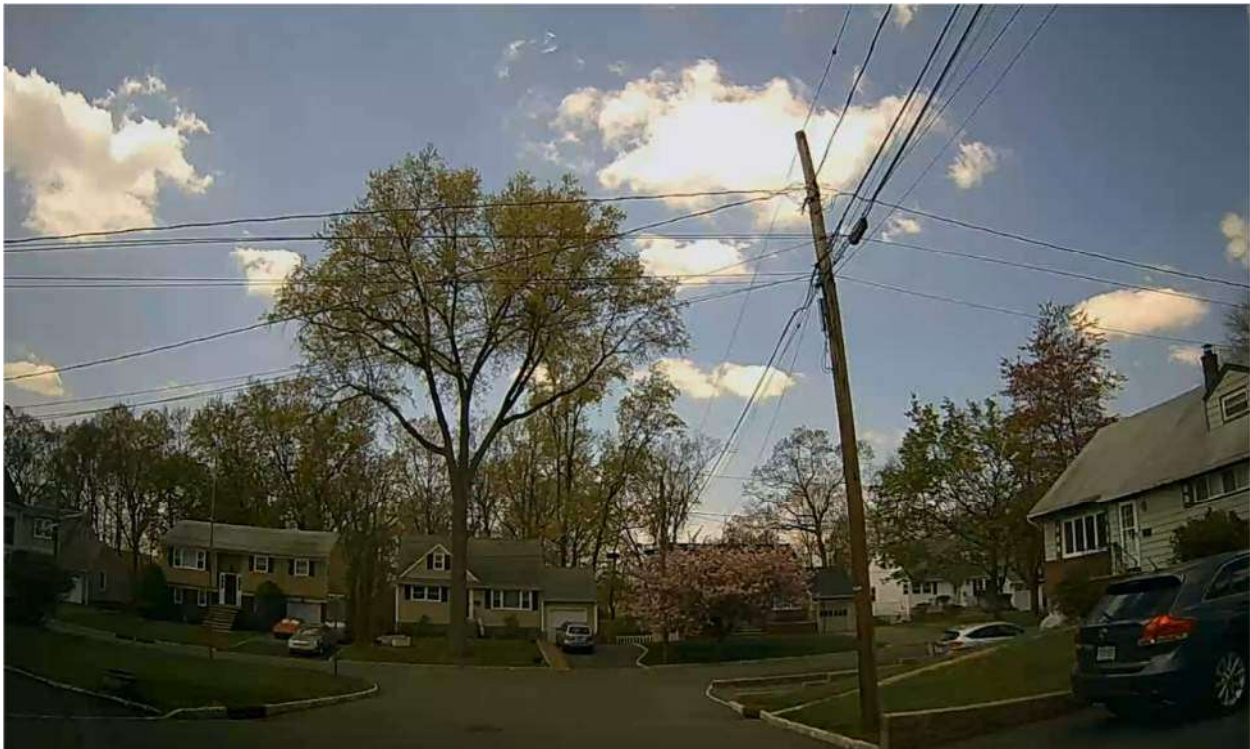
**FIGURE 2 – Abington Road & Seaman Road**

We observed that the sight lines at the intersection of Abington Road and Seaman Road are clear of obstructions.

It is our recommendation that a STOP sign be installed on the Abington Road approach at the study intersection. Treatments which can be considered include but are not limited to:

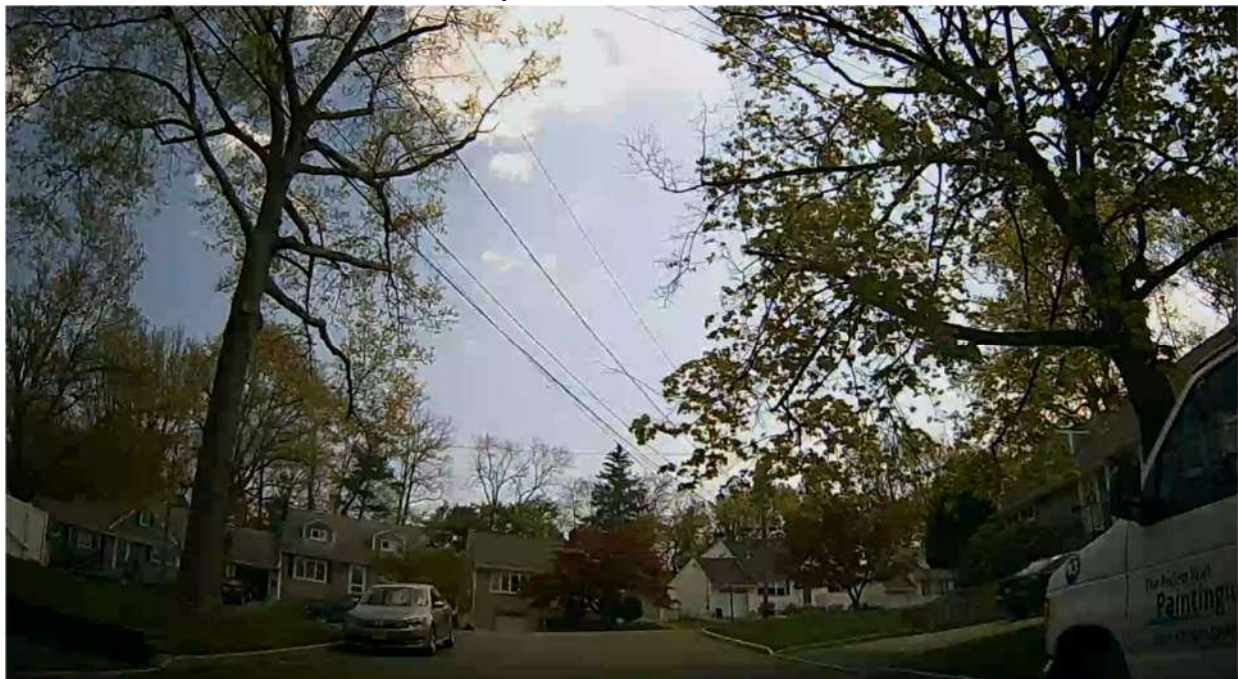
**FIGURE 2 – Bryn Mawr Road & Deerfield Drive**

We observed that the sight lines at the intersection of Bryn Mawr Road and Deerfield Drive are clear of obstructions.

It is our recommendation that a STOP sign be installed on the Bryn Mawr Road approach at the study intersection. Treatments which can be considered include but are not limited to:

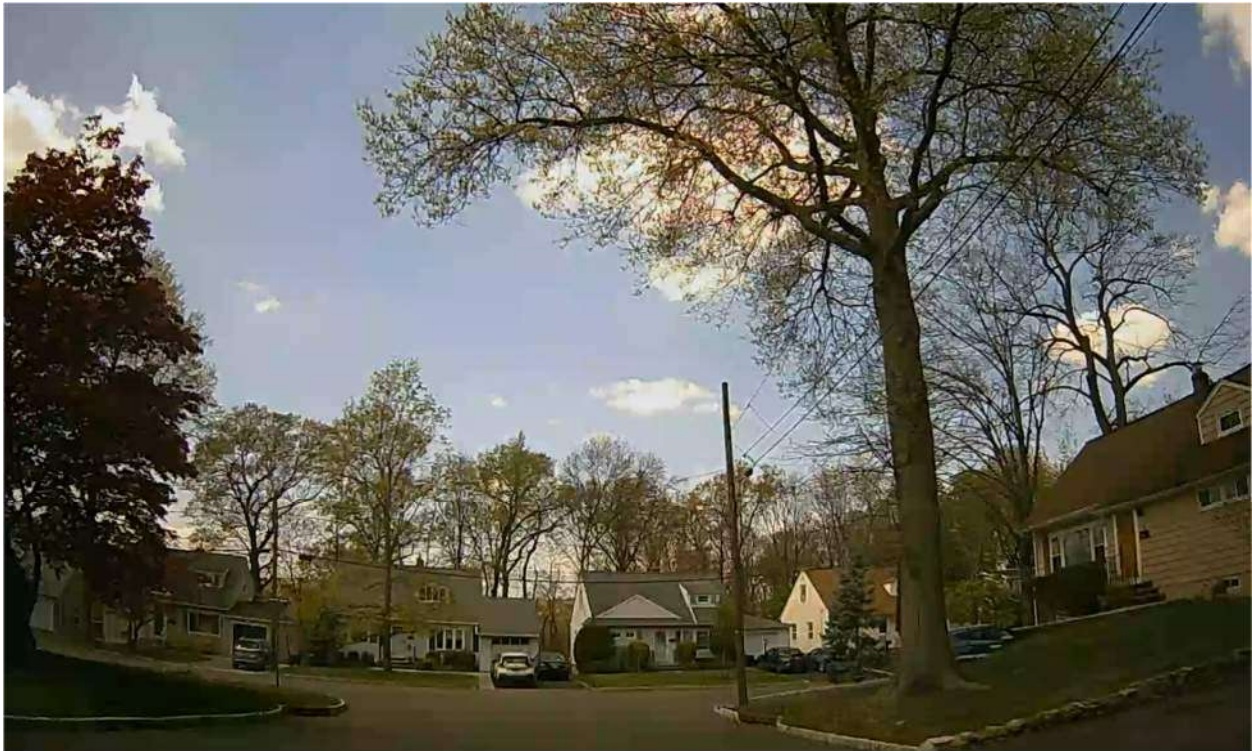
**FIGURE 2 – Bryn Mawr Road & Seaman Road**

We observed that the sight lines at the intersection of Bryn Mawr Road and Seaman Road are clear of obstructions.

It is our recommendation that a STOP sign be installed on the Bryn Mawr Road approach at the study intersection. Treatments which can be considered include but are not limited to:

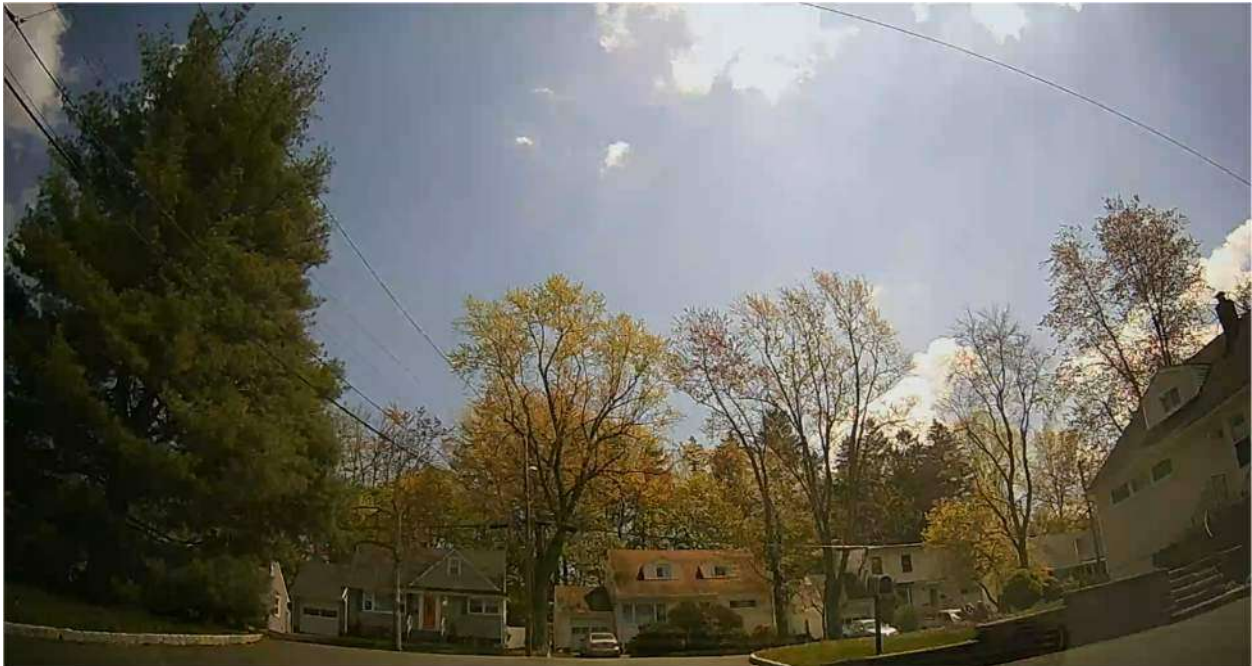
**FIGURE 2 – Stanley Road & Deerfield Drive**

We observed that a huge tree is obstructing the sight lines at the intersection of Stanley Road and Deerfield Drive; however, if vehicles pulled up closer to Deerfield Drive along the controlled approach, they would have improved visibility of traffic conditions at the intersection and would also be more visible themselves.

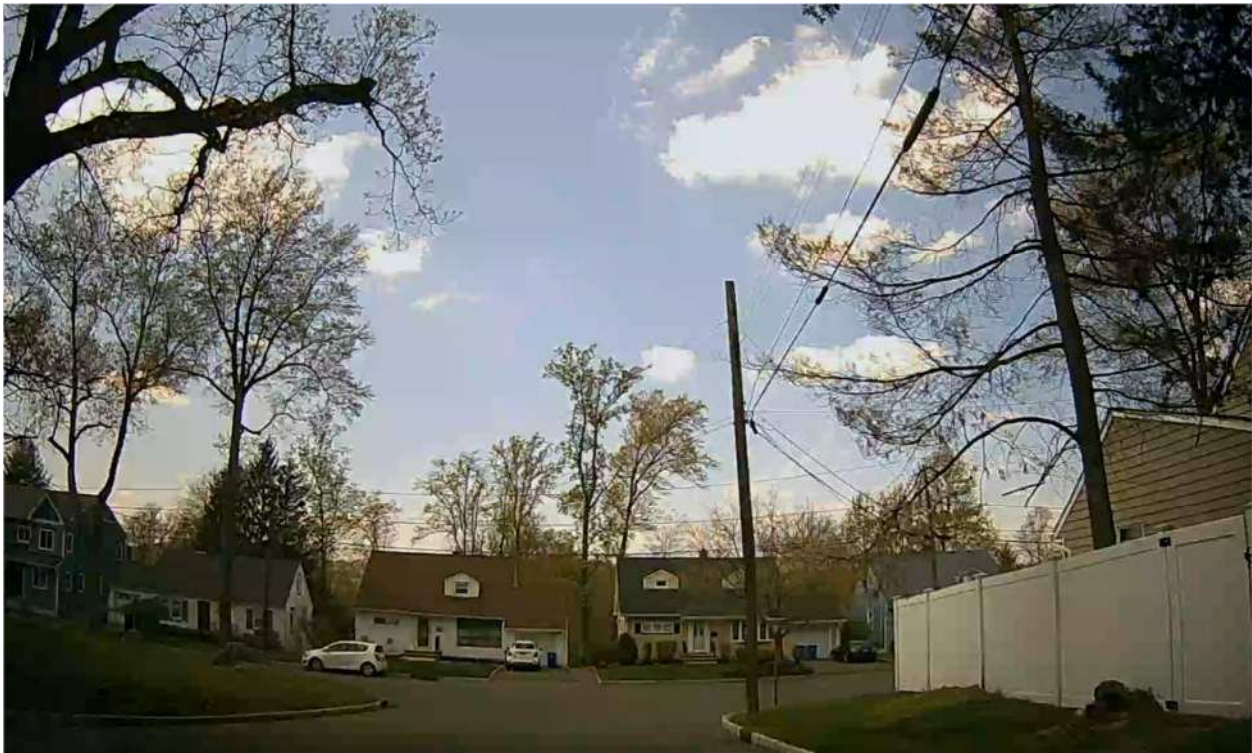
**FIGURE 2 – Stanley Road & Seaman Road**

We observed that the sight lines at the intersection of Stanley Road and Seaman Road are clear of obstructions.

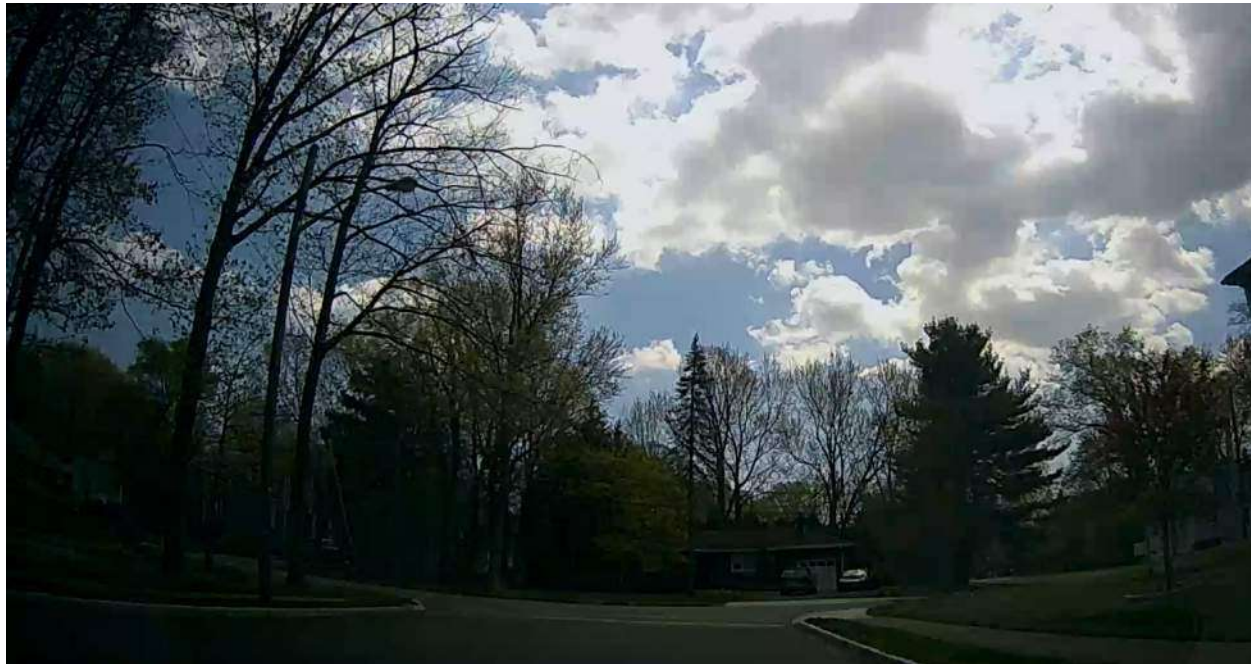
**FIGURE 2 – Knollwood Drive & Hillcrest Avenue**

We observed that the sight lines at the intersection of Knollwood Drive & Hillcrest Avenue and Ash Avenue & Hillcrest Avenue are clear of obstructions.

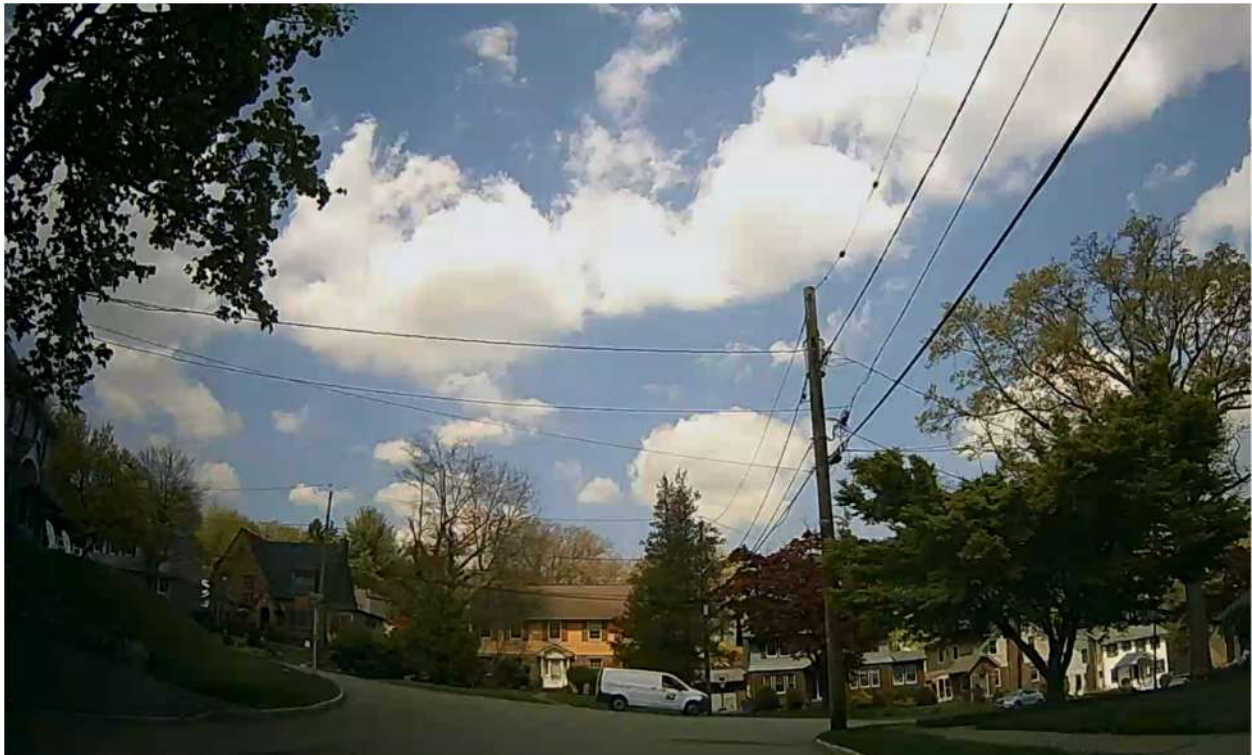
**FIGURE 2 – Luddington Terrace & Lowell Place**

We observed that the sight lines at the intersection of Luddington Terrace & Lowell Place are clear and free of obstructions.

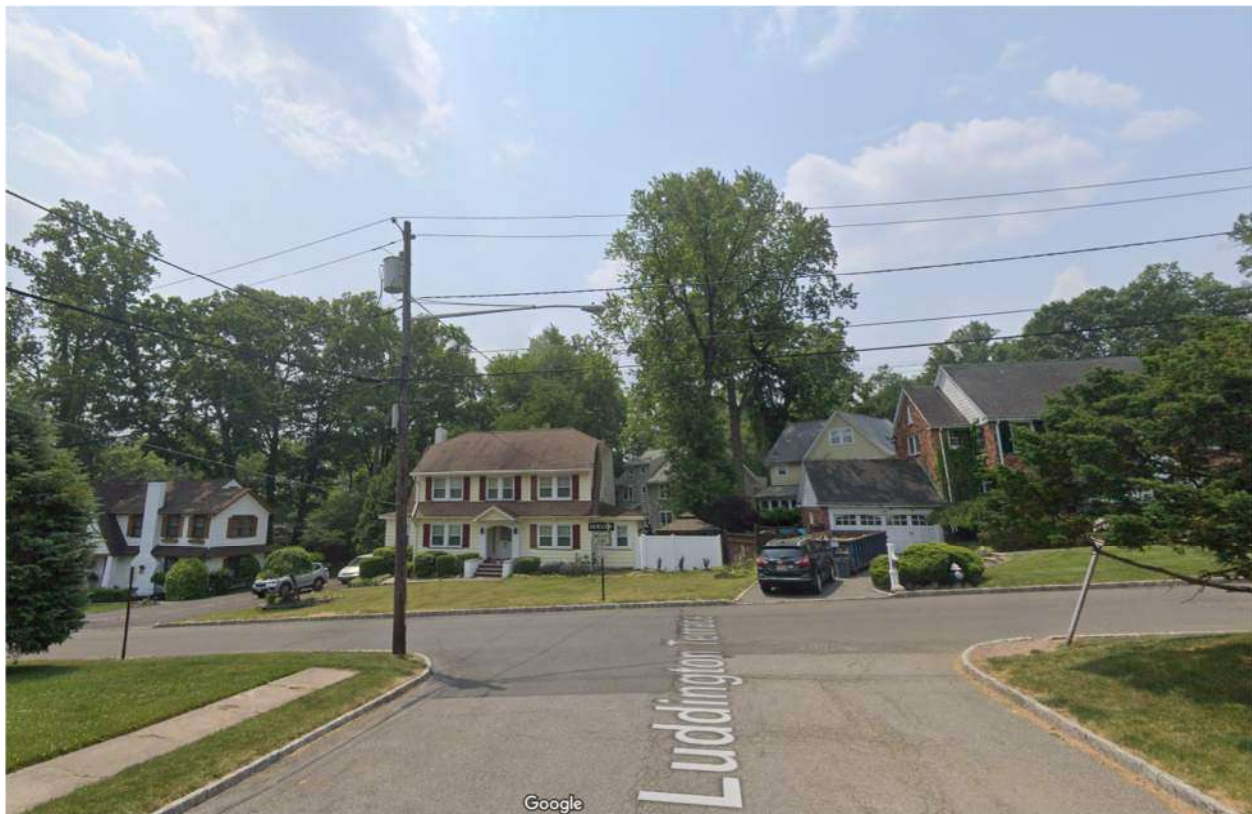
**FIGURE 2 – Luddington Terrace & Luddington Road**

We observed that the sight lines at the intersection of Luddington Terrace & Luddington Road are clear and free of obstructions.

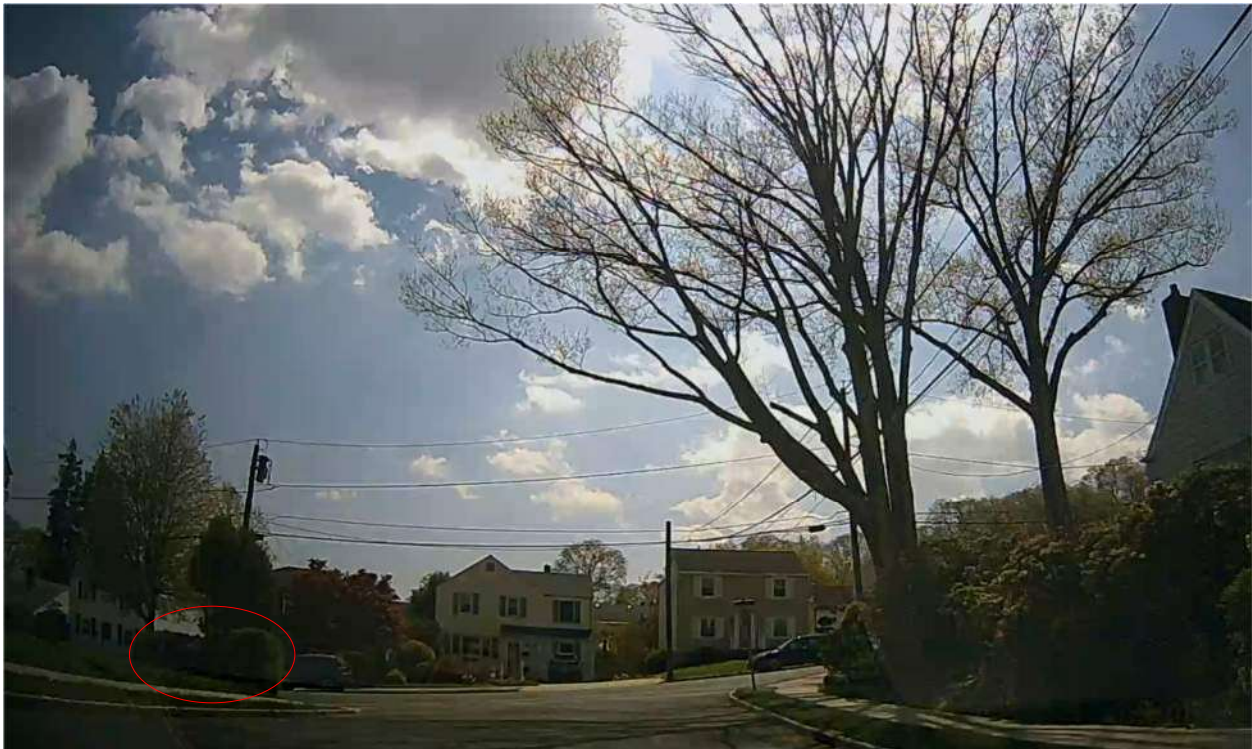
**FIGURE 2 – Bellevue Terrace & Nutwold Avenue**

We observed that the foliage at the corners of the study intersection is obstructing the sight lines for approaching vehicles; however, if vehicles pulled up closer to Nutwold Avenue along the controlled approach, they would have improved visibility of traffic conditions at the intersection and would also be more visible.

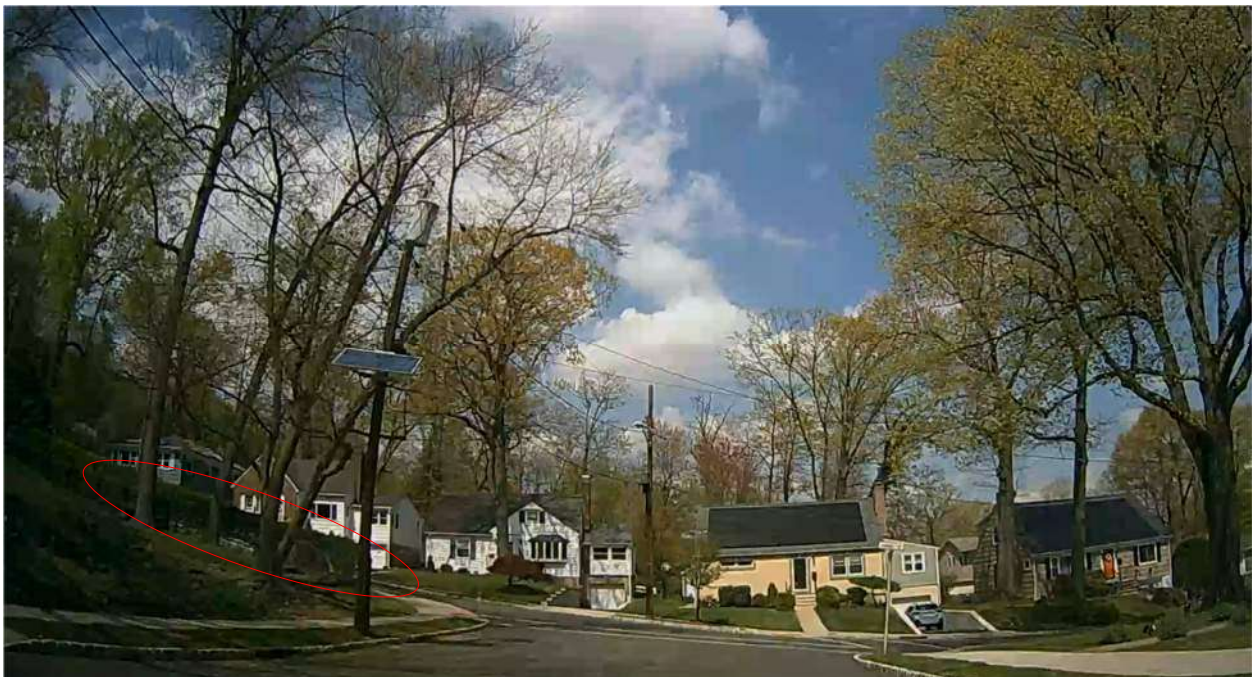
**FIGURE 2 – Bellevue Terrace & Harriet Street**

We observed that the foliage at the corners of the study intersection is obstructing the sight lines for approaching vehicles; however, if vehicles pulled up closer to Harriet Street along the controlled approach, they would have improved visibility of traffic conditions at the intersection and would also be more visible.

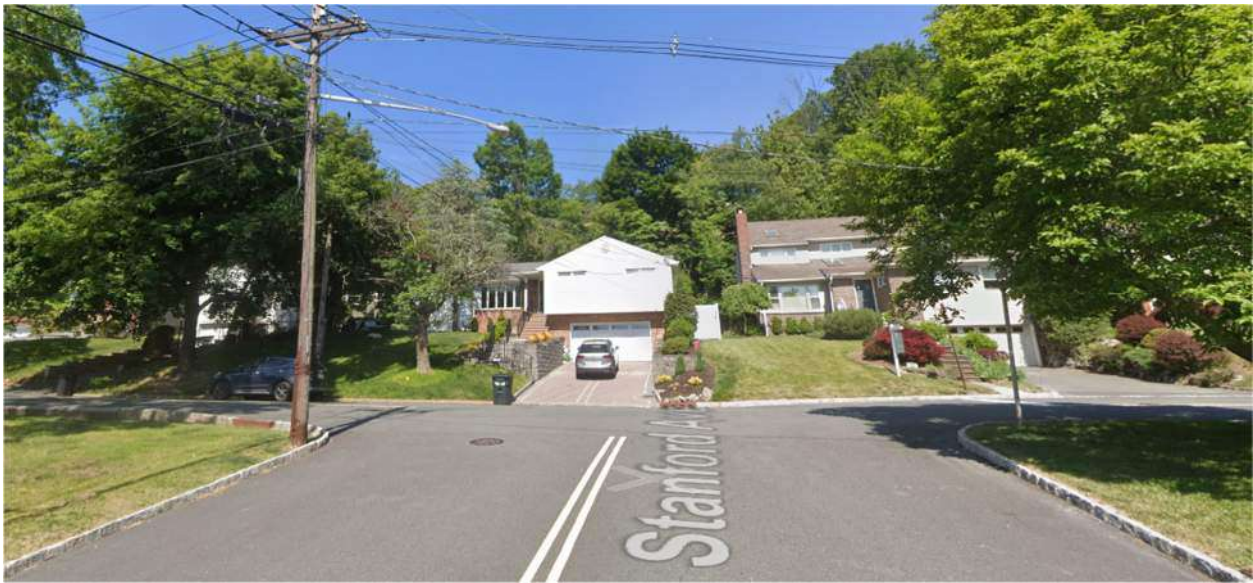
**FIGURE 2a – Stanford Avenue & Crestwood Drive (Stanford Avenue WB Approach)**

We observed that the horizontal sight lines at the intersection of Stanford Avenue & Crestwood Drive are clear of major obstructions. We observed that the vertical sight lines from Crestwood Drive (southbound approach) to the study intersection is clear.
