**RE: Exposed Rock Face Review**  
Proposed Residential Subdivision  
2-10 Ridge Road  
Block 80.03, Lots 10 & 21  
Township of West Orange  
Essex County, New Jersey  
Dynamic Earth Project No.: 4266-99-001EC

Dynamic Earth, LLC (Dynamic Earth) has completed a rock slope review for the above referenced site. The results of our review are detailed herein.

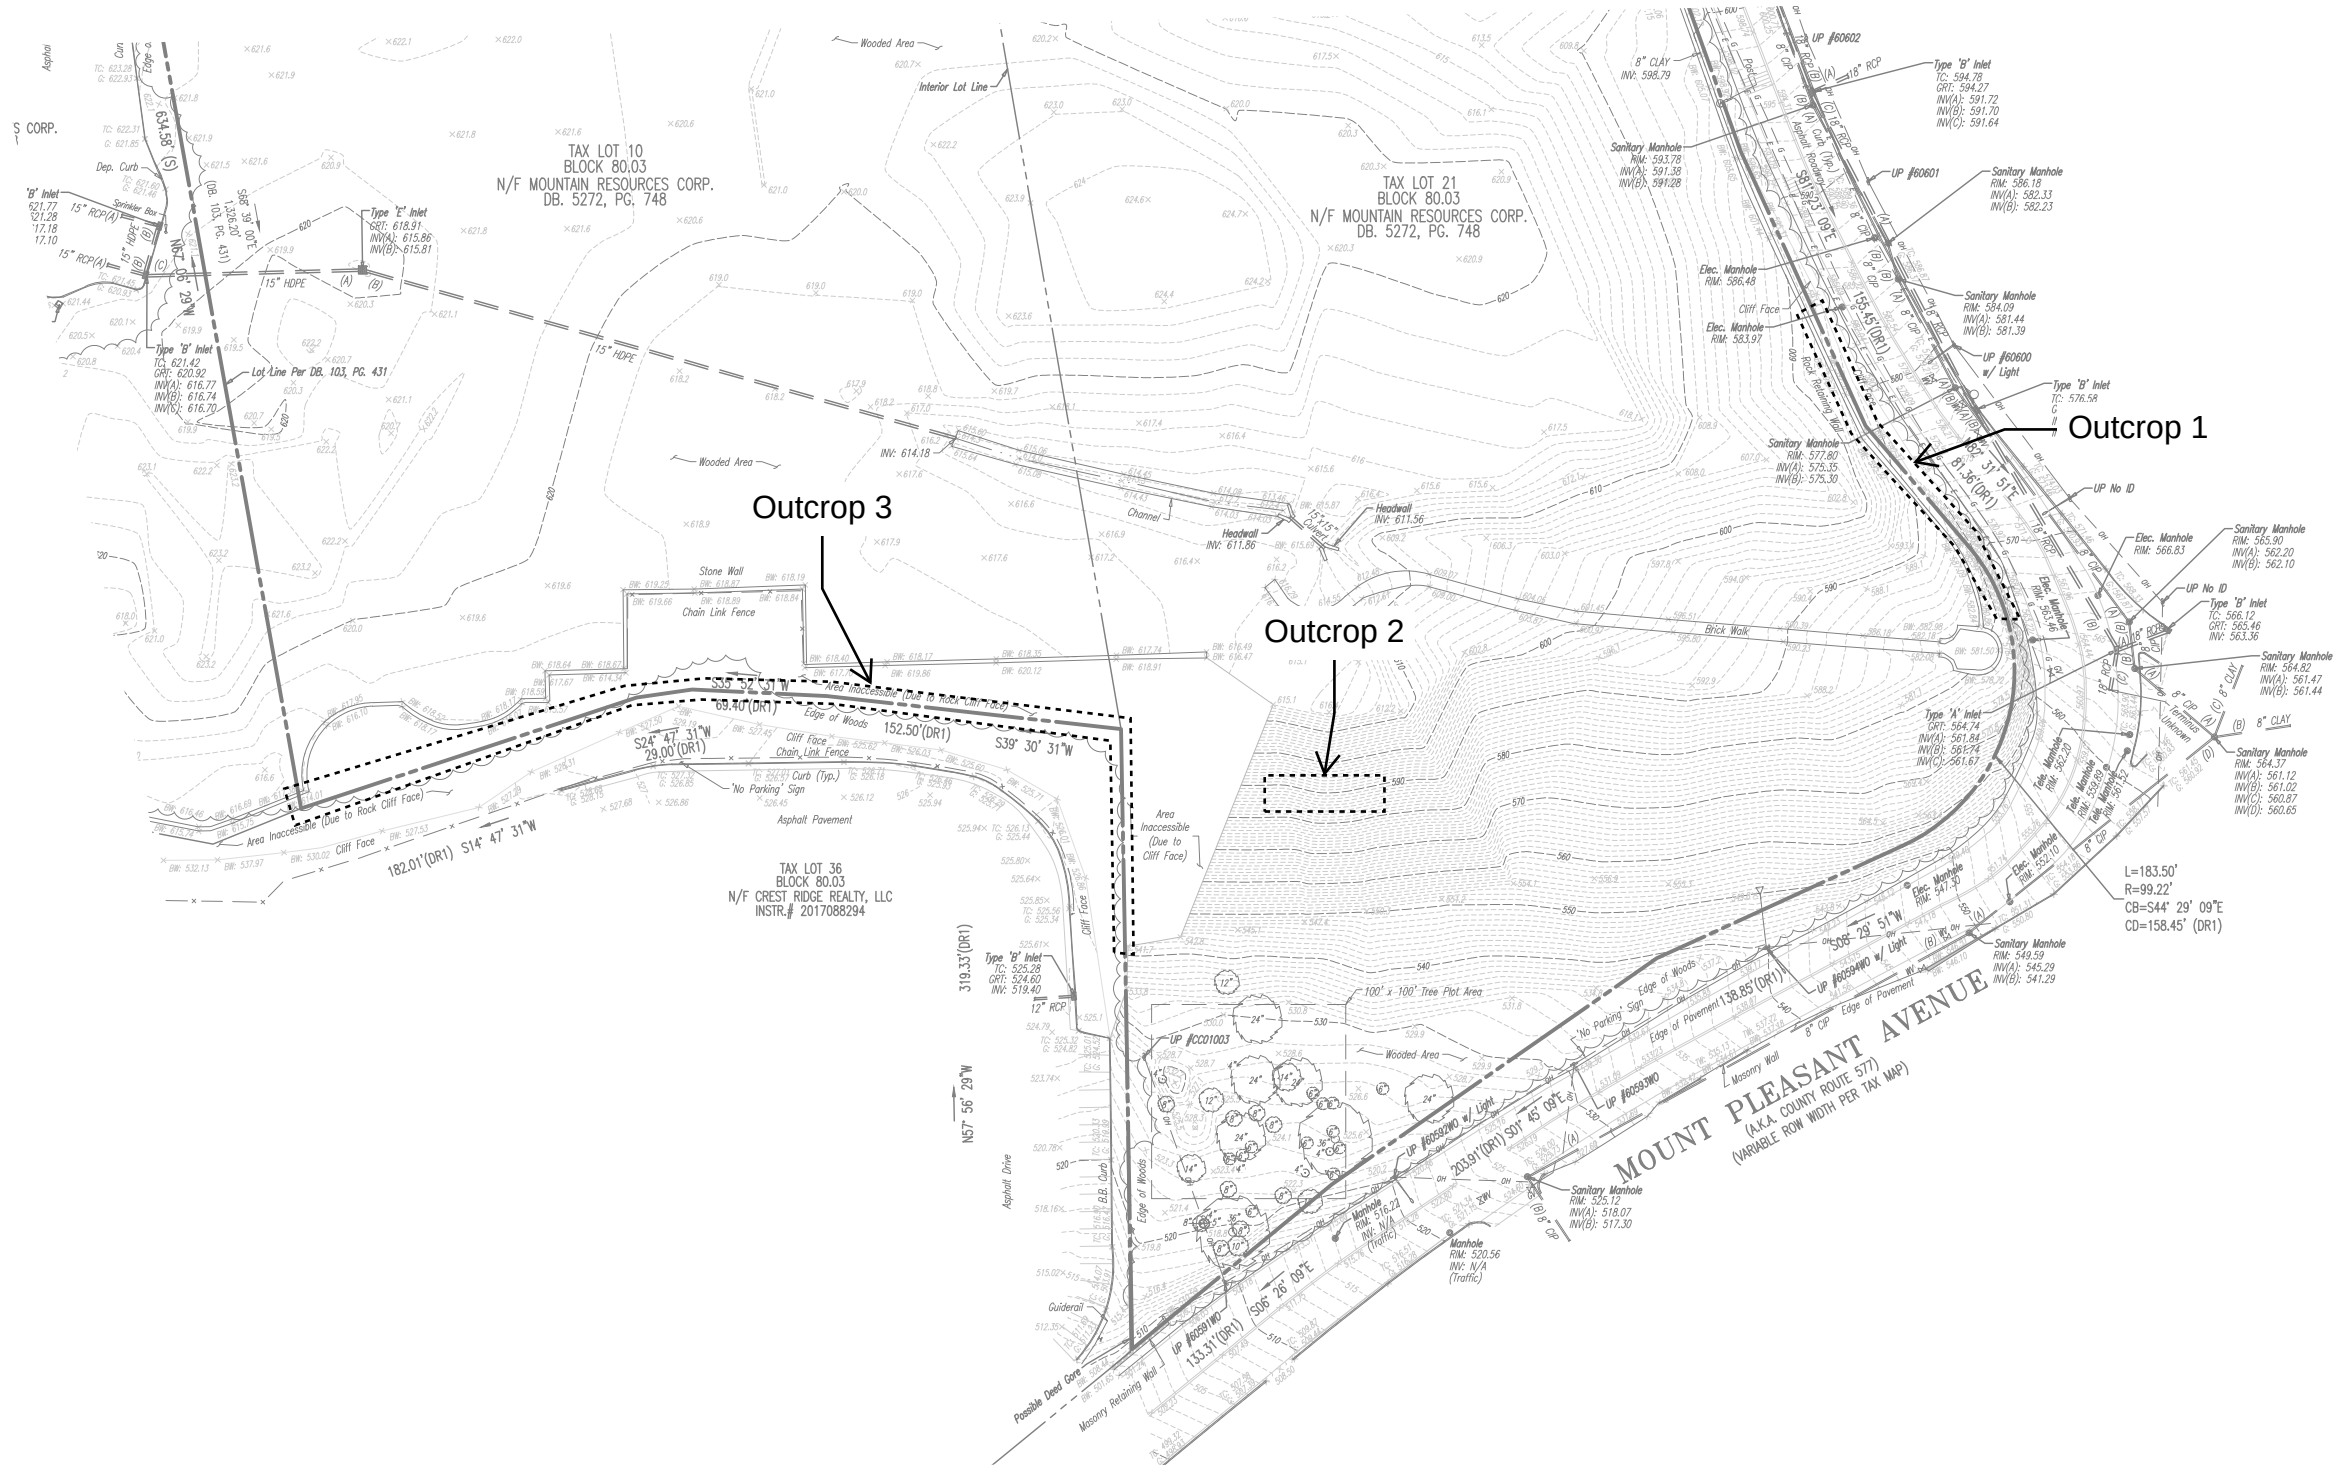
## **Outcrop Location Plan**

Rock outcrops located along the northeast portion of the site (outcrop 1) indicated seepage and wetness. The presence of seepage and icicles could be a potential indicator of instability. Water filled discontinuities can potentially reduce the effective shear strength along the discontinuity plane by means of hydrostatic forces. In addition, the formation of ice can destabilize the block form of the rock face causing breakage of joint bonds. Outcrops 2 and outcrops 3 did not show signs of seepage or formation of ice at the time of our site visit. However, these areas should be monitored particular following precipitation and/or during the wet seasons of the year.

Based on our observations and review, preliminary project planning should include keeping building developments at least 100 feet from existing and observed rock outcrops. An approximate area is shown on the attached *Rock Outcrop Buffer* plan. The slopes observed during the field investigation indicated soil cover over bedrock. If the development limited to the area outside of the proposed buffer area, the rock slopes are anticipated to have minimum impact from the development.
